# Economical Inspection Methods Assisted by Unmanned Aerial Vehicle for Bridges in Korea

**Keywords:** bridge, maintenance and inspection, crack detection, water leak, white coating, UAV

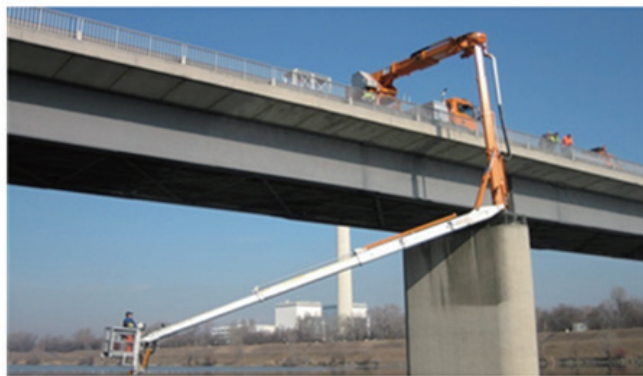
Fig. 1. (Color online) Close inspection using bridge inspection vehicle.

facilities is conducted within 6 months after the completion of construction or from the date of granting approval for use (including temporary use). A regular close inspection involves an accurate assessment of the current status of infrastructure facilities, an assessment of changes from the initial or previously recorded status, and a confirmation that the infrastructure facilities satisfy the requirements for use. In addition, a closer naked-eye inspection is performed using simple measuring instruments and bridge-specific inspection vehicles if needed. A regular close inspection is conducted at least once every 2 years. Figure 1 shows a photograph of a close inspection using an inspection vehicle.

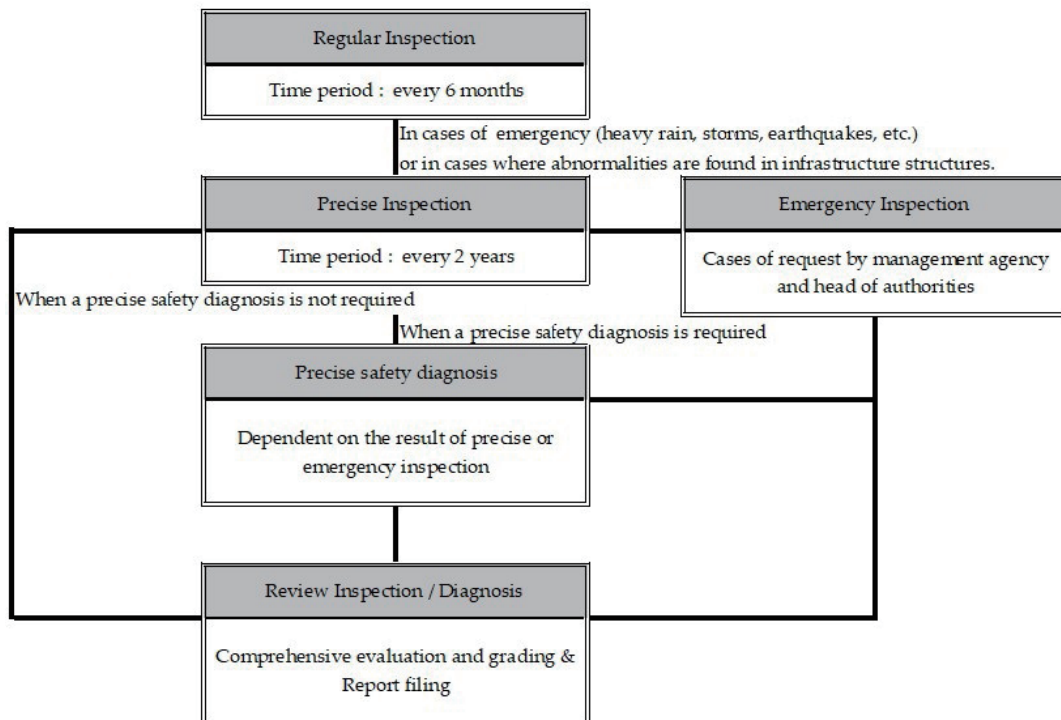
Fig. 2. Bridge inspection procedure.

An emergency inspection is conducted when it is considered necessary by a managing body or when a managing body is requested to do so by the heads of relevant administrations. The emergency inspection is composed of damage and special inspections. A damage inspection is a nonscheduled inspection designed to immediately check the damage to the infrastructure caused by disasters or accidents. A special inspection is conducted at a level similar to a close inspection in cases where a defect such as foundation subsidence or scouring is suspected or where the continuous usability of infrastructure facilities that are prohibited from use needs to be assessed. A precise safety diagnosis is conducted when it is considered necessary to prevent disasters, ensure the safety of infrastructure facilities, and so forth, by a managing body based on the results of a safety inspection. The purpose of a precise safety diagnosis is to check, analyze, and assess the structural safety, causes of defects, and so forth; to identify physical and functional defects in infrastructure facilities; and to adequately and promptly address any problems. Another purpose of the diagnosis is to suggest methods for repair and reinforcement. The features of each bridge inspection type are briefly described in Fig. 2.<sup>(2)</sup>

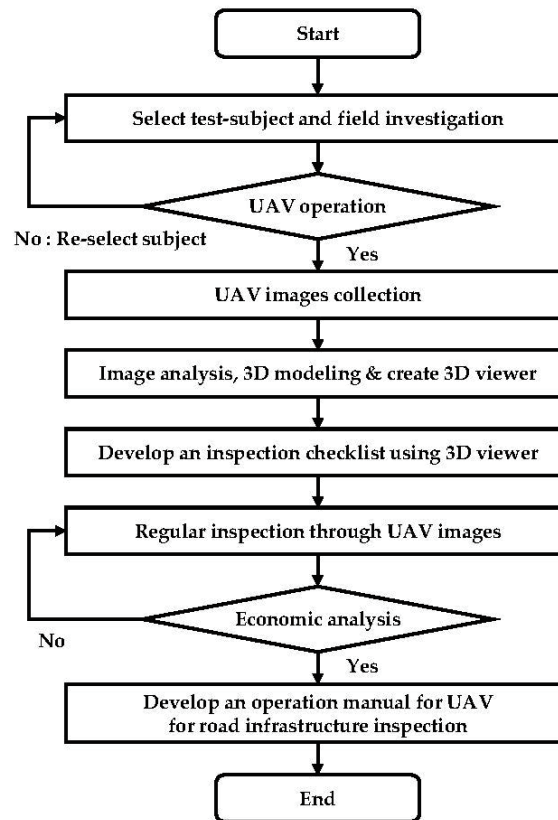
Fig. 3. Flowchart for UAV-based bridge maintenance.

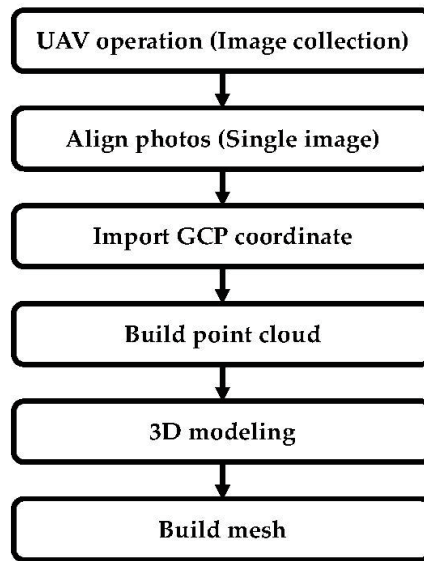
Fig. 6. Process for image matching.

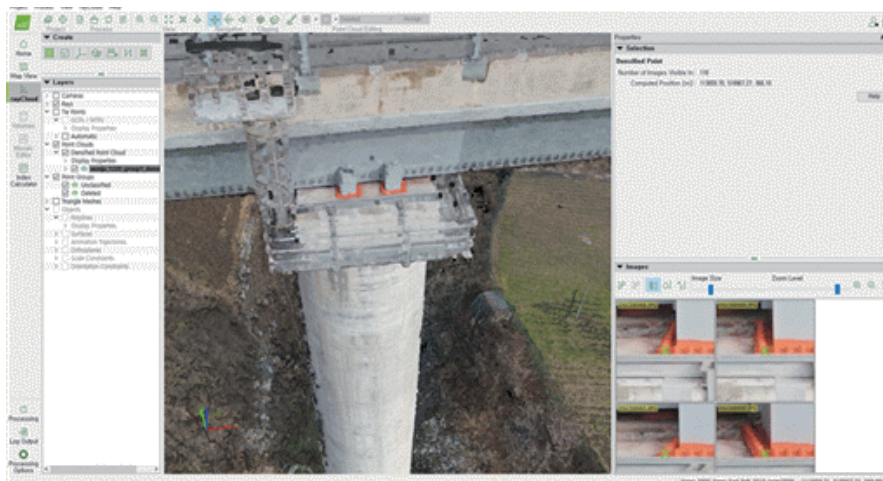
Fig. 7. (Color online) Results of image matching.

PIX4D Mapper software was used to process the obtained UAV images. The international system of WGS94 coordinates was used for the coordinate system, and the variable values of the camera used for recording were considered in the processing. Figure 6 shows a flowchart of the general UAV image processing. Figure 7 shows the outcomes depicted as 3D models generated from the image processing.

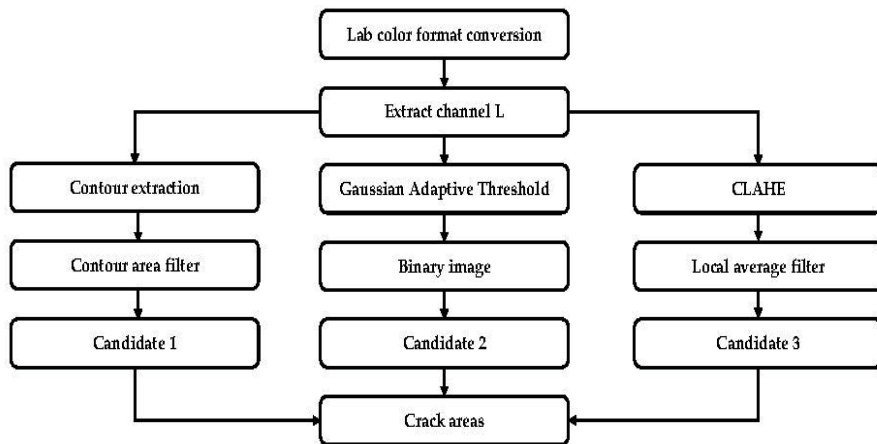
Fig. 9. Flowchart for crack detection.

In the image of the bridge, cracks were generally indicated in a darker color than the other areas. To use this feature, the color format conversion was carried out in the first step (Fig. 9). The recorded image was in RGB color format, which was then changed to Lab color format. To use channel L, data were extracted from channel L in the second step. The extracted channel L

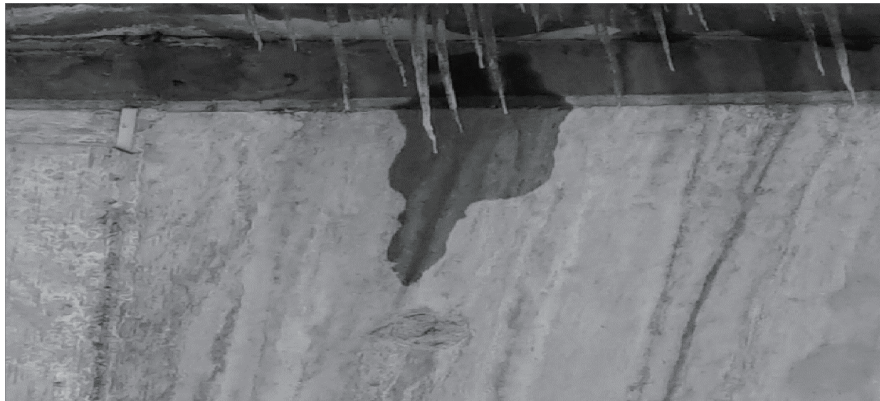
Fig. 16. Channel L data.

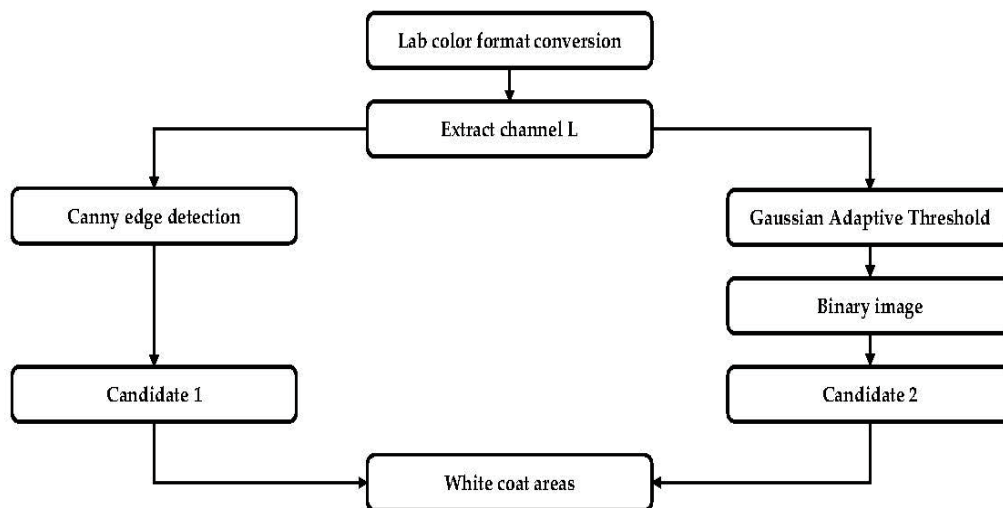
Fig. 21. Flowchart for white-coated area detection.

obtained from the Lab color format in the first step (Fig. 21). As in the other cases, Canny edge detection and the Gaussian adaptive threshold method were used in the second step.

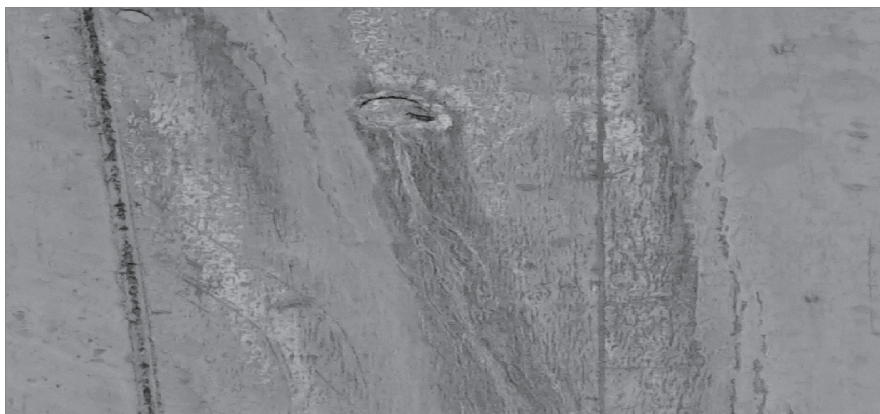
Fig. 22. Channel L data.

Figure 22 explains the first step for extracting channel L from Lab color format. When whitecoating occurred, more edges were found in the efflorescence area than in the other areas. Therefore, the edges were detected through Canny edge detection from Fig 23. The detected edges were designated as efflorescence candidate 1, as shown in Fig. 24. As the efflorescence area had higher lightness values than the surrounding areas, the data were extracted only when the value exceeded a threshold value, and a binary image was obtained by another method, as shown in Fig. 25. This image was designated as efflorescence candidate 2. Then, the intersection of efflorescence candidates 1 and 2 was measured, and the efflorescence areas with higher lightness values than the surrounding areas as well as many edges within the efflorescence areas were detected in the final step. The detected efflorescence areas are shown in Fig. 25.

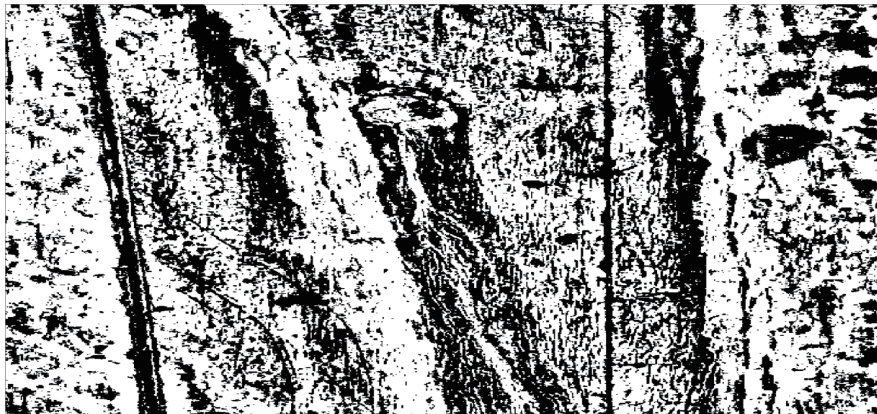
Fig. 24. Image obtained from Gaussian adaptive threshold method.

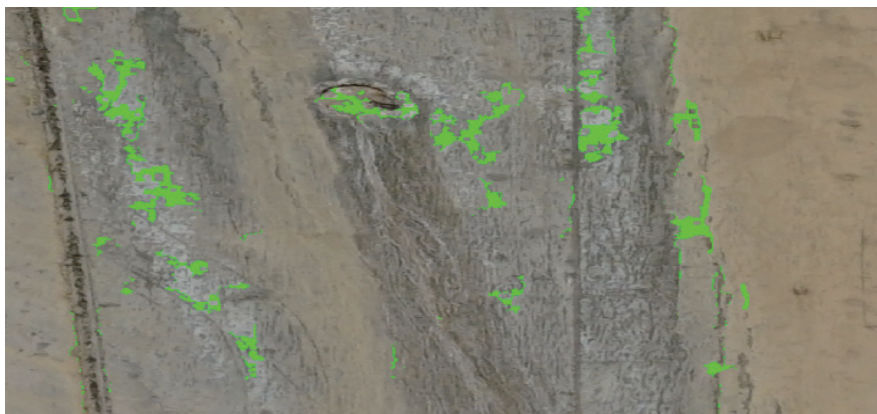
Fig. 25. (Color online) Image obtained from white-coated detection.
