# Application of Line Scan Technology for Defect Inspection in Plain Dyed Fabric

Yu-Liang Chen, Chia-Wei Tsai, Fan-Siou Ding, and Quang-Cherng Hsu\*

Department of Mechanical Engineering, National Kaohsiung University of Science and Technology,  
No. 415, Jiangong Rd., Sanmin Dist., Kaohsiung City 80778, Taiwan

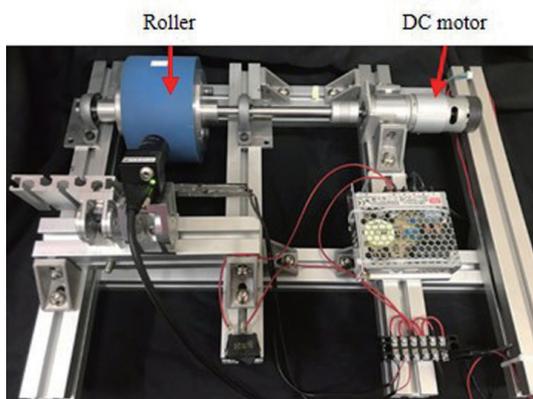
Fig. 1. (Color online) Device for the simulation of fabric transfer.

1) System architecture: A roller device (diameter 120 mm) was powered by a direct current motor to simulate the fabric transfer process in the dyeing and finishing processes. In addition, a single camera (IDS UI-3880CP-C-HQ Rev.2) with a line scan function and closed-circuit television lens (focal length 6 mm; aperture f2.0) was used as the imaging device. The captured images were transferred to the workstation (which was equipped with a GeForce RTX2060 Dual O6G graphics card) through USB 3.0 for processing and defect inspection (Fig. 1). The direct current motor had a fixed rotation speed. The rotation speed (142.8 rpm) of the roller device was determined by using a digital laser tachometer (DT-2234C+). The rotation speed was then converted into a flat speed, and the tangential rotation velocity was 0.9 m/s.

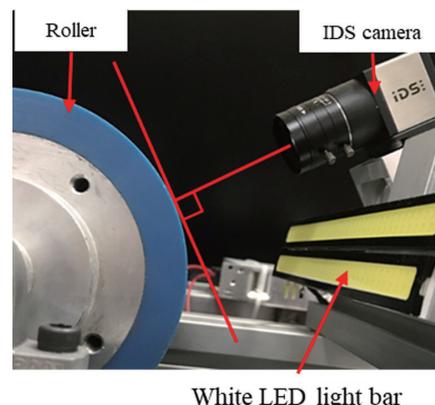
Fig. 2. (Color online) Camera installed in the normal direction from the surface of the simulation roller.

The IDS camera had a resolution of  $3088 \times 2076$  pixels. In line scan mode, the maximum resolution was 24 million pixels ( $3088 \times 8000$  pixels). In line scan mode, the maximum image width was 8000 pixels and a single scan had a width of 2000 pixels. The light source originally used at the fabric inspection site was a fluorescent lamp, which was not sufficient for the purpose of this study. Therefore, a white LED light bar (length 170 mm) was used as an alternative (Fig. 2). Direct bright field lighting was the light source in the simulation. Moreover, the camera was installed in the normal direction from the surface of the simulation roller to capture images.

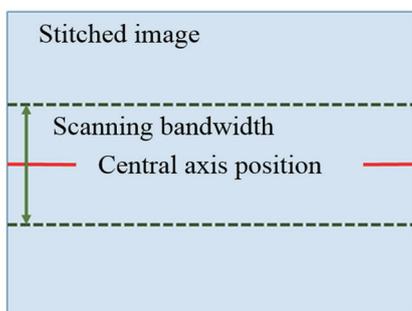
Fig. 3. (Color online) Line scanning benchmark.

2) Line scan processing: Before the line scan function was used, a scan starting point must first be set. As shown in Fig. 3, the central axial position of the roller was selected as the benchmark; therefore, the pixel of the scan position must first be set as the  $y$ -axis position. As shown in Fig. 4, uEye Cockpit was used to set the location of the central axis of the roller at 1080 pixels. Figure 5 presents a  $30 \times 30 \text{ mm}^2$  square piece that was mainly used to calibrate the size of the captured images. For the successive adjustment of the parameter values—specifically, the number of lines in the vertical AOI merge mode in uEye Cockpit—the piece was adhered onto the surface of the simulation roller. Related parameters for adjustment settings to test whether the distortion of the stitched image was related to the pixel clock (PCLK) rate and the number of single scans (i.e., the number of lines) were provided by uEye Cockpit software. In addition, the brightness parameter was used to adjust the baseline light source of the images.

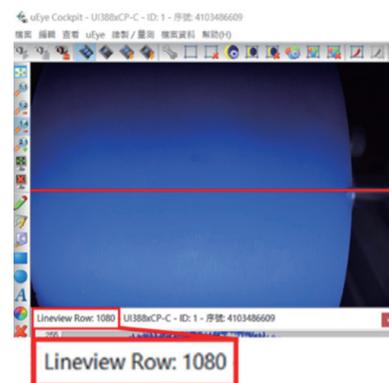
Fig. 4. (Color online) Central axis of the roller (1080 pixels).

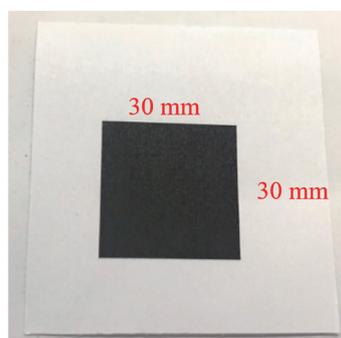
Fig. 5. (Color online) Square piece used for calibration.

The number of single scans affects the degree of image distortion after stitching, which in turn causes errors in defect identification and analysis. Figure 5 presents the  $30 \times 30 \text{ mm}^2$  square used as the calibration piece for image stitching. Different combinations of the number of scans (rows) and the PCLK (MHz) can be used for testing and determining the difference between the length and width pixel values of the stitched image. Smaller differences between the length and width indicated less distortion and a more rectangular shape.

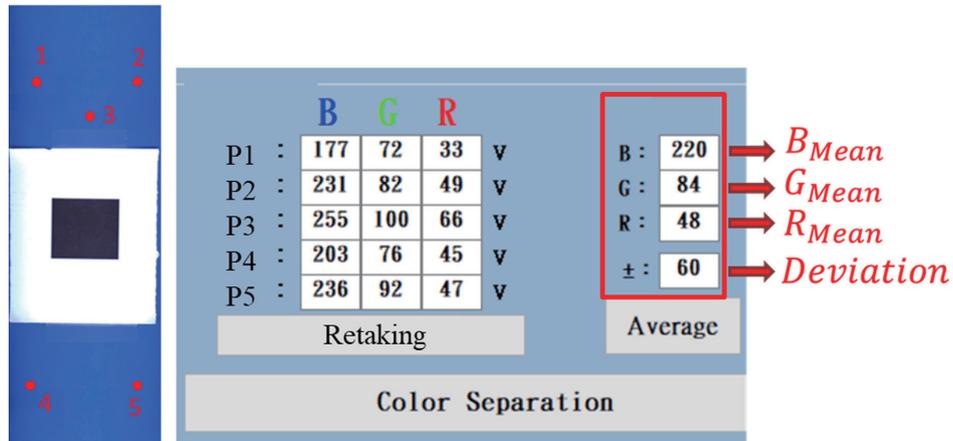
Fig. 6. (Color online) Selection of five points for the posterization of the RGB values to identify their respective means.

As shown in Eq. (1), the maximum and minimum RGB values were set, and each pixel in the image was analyzed accordingly. If the RGB values of the pixels were within the set range, the pixel value was set to 255 (white). By contrast, if one of the values was outside the set range, pixel value was set to 0 (black). The means and standard deviations of each RGB value in Eq. (1)

were the deviations between the mean and the threshold value of the five selected points, respectively.

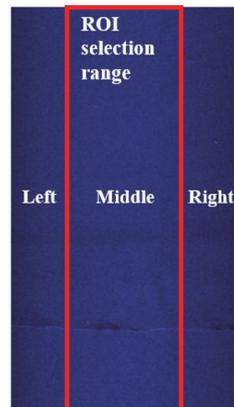
Fig. 7. (Color online) ROI with dark areas to the left and right.

The find contours function in OpenCV, a library of programming functions, can be used to extract contours from binary images. If a contour is identified through contour detection, and the contour area is within the set maximum and minimum range, it is regarded as a defect. Uneven illumination can cause the dark areas on the left and right sides of an image to result in defect outputs. To mitigate this problem, a ROI selection function was added to divide each image into two regions: the middle ROI selection range and the left and right sides of the ROI, as shown in Fig. 7. Different standard deviation ( $\pm$ ) values were used in each region.

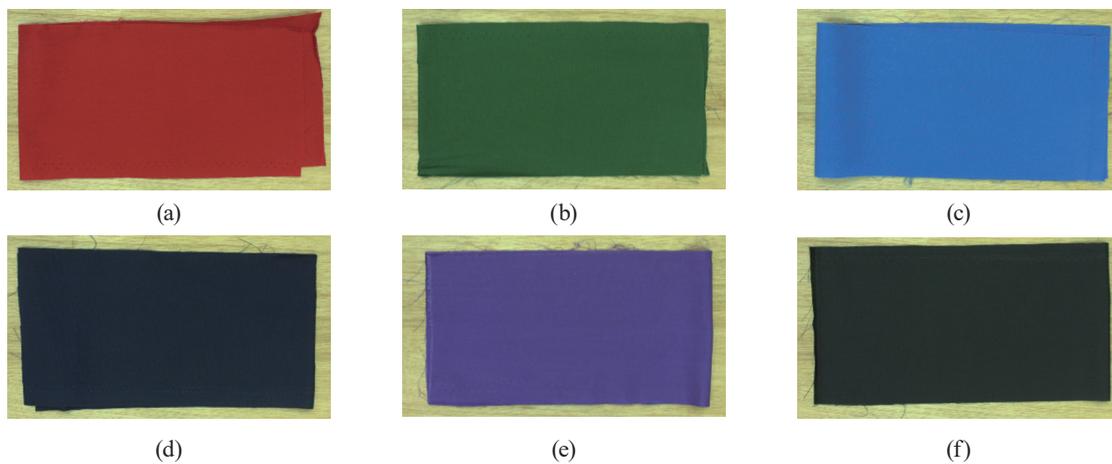
Fig. 8. (Color online) Test fabrics of various colors. (a) Red, (b) green, (c) light blue, (d) dark blue, (e) light purple, and (f) black.

The AOI system was tested to determine whether it can effectively identify defects in fabrics exhibiting variations from the dyeing and finishing processes. Therefore, plain cotton fabrics of different colors were subjected to inspection. Fabrics of both light and dark colors were used: red, green, light blue, dark blue, light purple, and black. As shown in Fig. 8, each type of fabric was divided into three groups. The first group was used to determine the posterization parameters (initial value settings), the second group comprised fabrics with no defects for testing (adjustment), and the third group consisted of defective fabrics for testing.

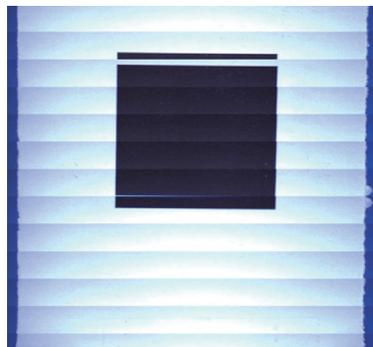
Fig. 9. (Color online) A PCLK rate of 118 MHz was insufficient, as indicated by the obvious gap in the captured image.

As shown in Fig. 9, when the PCLK rate was set to 118 MHz, image separation was apparent. Therefore, this rate was excluded from further analysis.

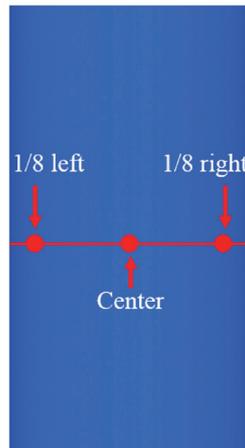
Fig. 10. (Color online) Schematic of three analytical points.

The pixel values of three points 1/8 left of the center, at the center, and 1/8 right of the center were selected, and the maximum difference between the pixel values of the three points was analyzed (Fig. 10).

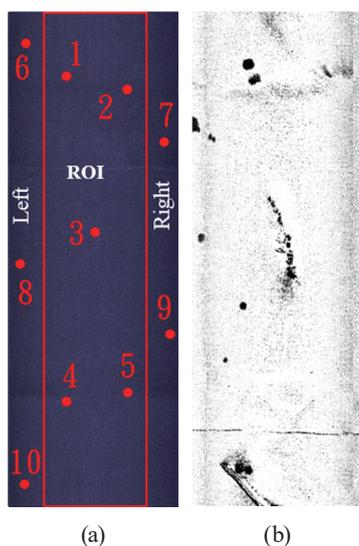
Fig. 11. (Color online) Partition analysis of the line scan image. (a) ROI and outer regions; (b) inspection result.

Uneven illumination of the images captured in line scan mode, which led to incorrect detection of defects, was observed during the inspection process. As shown in Fig. 11(a), the newly added ROI function selected the middle region, and five points were also selected from the evenly and randomly distributed left and right sides (outer region). Subsequently, posterization was used to process the image range of different regions. Considerable speckle noise was noted, as shown in Fig. 11(b).

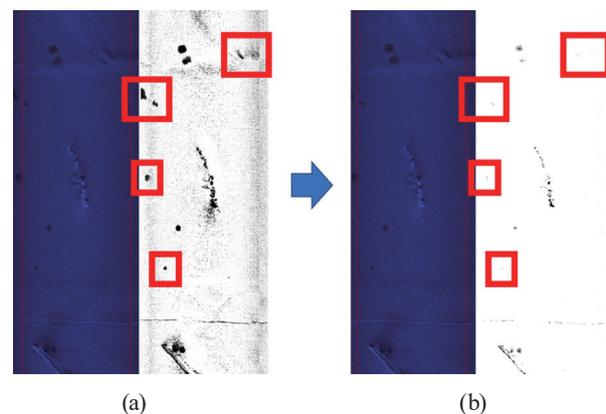
Fig. 12. (Color online) Results from the different threshold deviation ( $\pm$ ). (a) The same value was used for the inner and outer parts of the ROI; (b) adding a ( $\pm$ ) value to the outer ROI reduced the noise.

As shown in Fig. 12, when the threshold deviation ( $\pm$ ) differed according to the region, adding a ( $\pm$ ) value to the outer ROI reduced the analytical problem of dark peripheral areas. However, numerous defect features were also eliminated. This demonstrates that simply increasing the value of ( $\pm$ ) for noise removal causes the considerable loss of defect features.

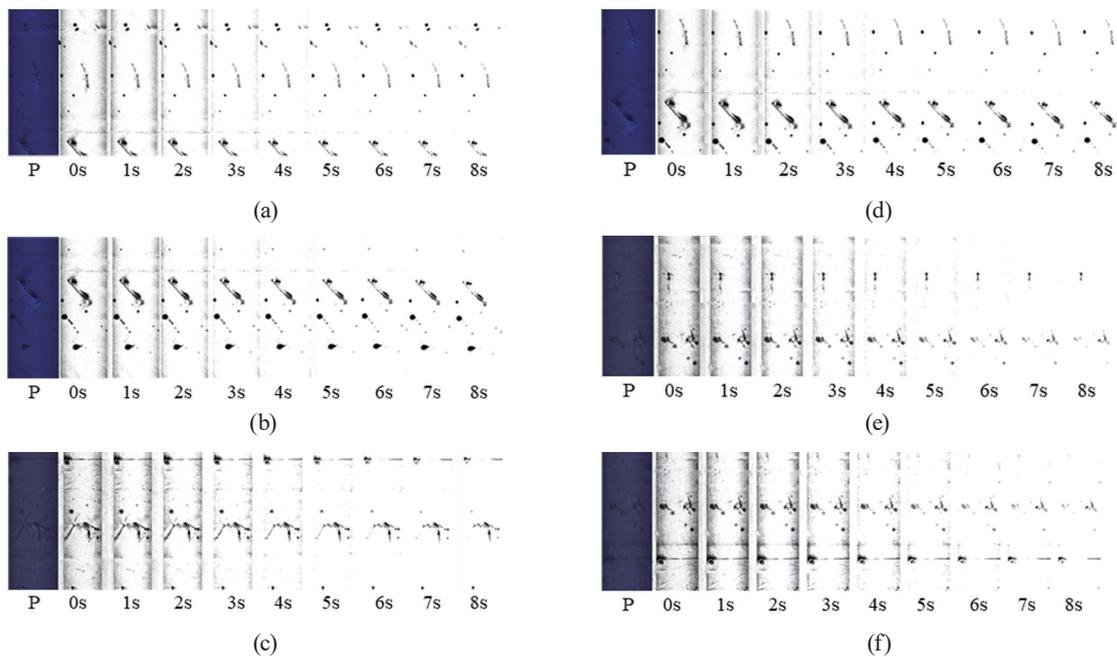
Fig. 13. (Color online) Analysis of defect features in ROIs in the posterized images with different closing times. (a) Dark blue #1, (b) Dark blue #2, (c) Dark blue #3, (d) Black #1, (e) Black #2, and (f) Black #3.

The defect feature analysis revealed that posterization with ROI selection outperformed posterization alone, with one shortcoming: the generation of a substantial amount of speckle noise. In general, when it is applied to AOI, the speed will be slowed, and the inspection efficiency will be reduced. Therefore, before image adjustment with ( $\pm$ ) values, closing was used for speckle noise removal, and the results were compared for different times of closing. After the completion of posterization for the dark blue fabric, better detection results were observed for the image obtained from five closings. Five closings also resulted in the optimal results for the black fabric (Fig. 13).

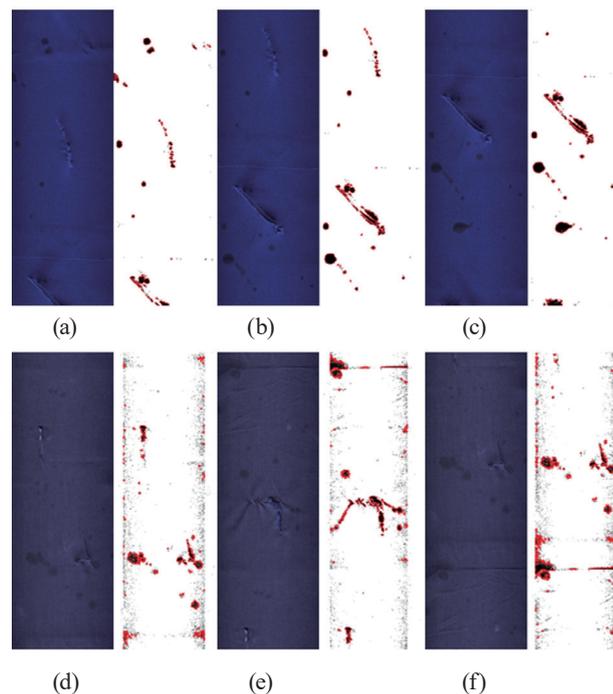
Fig. 14. (Color online) Posterization of ROI + initial ( $\pm$ ) value of threshold deviation + closing.

Table 5 lists the image processing parameters, various combinations of which were tested to determine the optimal inspection method. Posterization of the ROI and the initial ( $\pm$ ) value combined with closing effectively eliminated noise and accurately detected defects, with only a slight loss of defect features. This method was successfully used to inspect defects in dark blue and black fabrics. Subsequently, contour detection was applied to the defect features (Fig. 14).

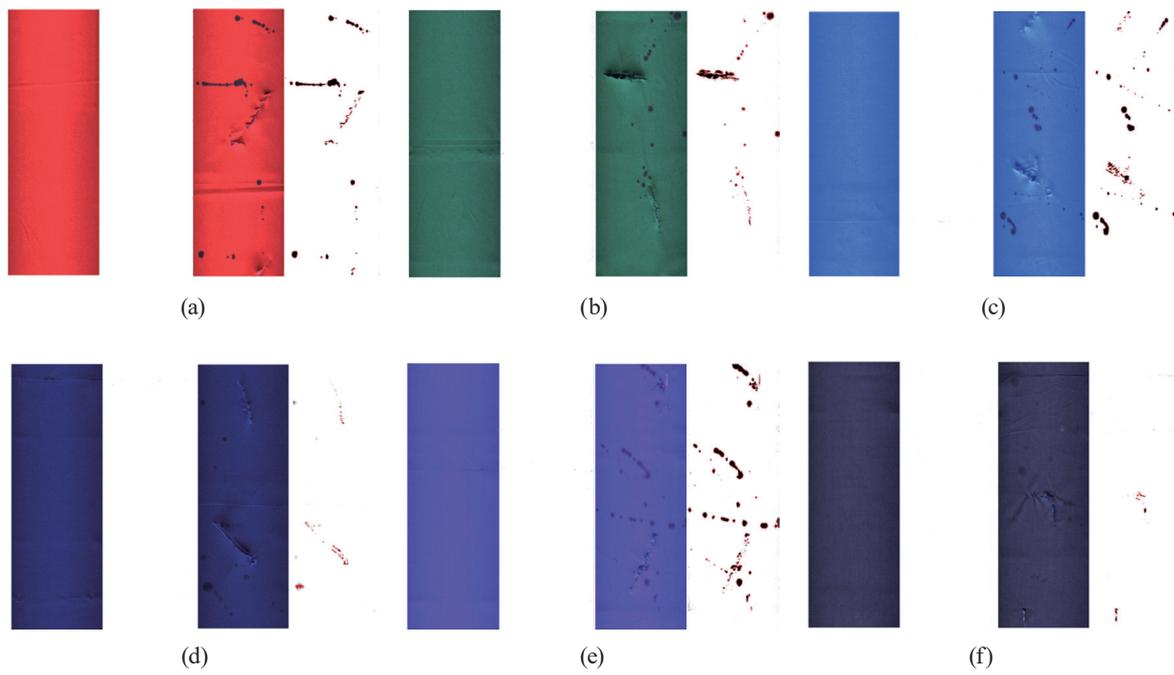
Fig. 15. (Color online) Fabric testing results. (a) Plain red fabric, (b) plain green fabric, (c) plain light blue fabric, (d) plain dark blue fabric, (e) plain light purple fabric, and (f) plain black fabric.

Figure 15 presents the testing results for both the defective and nondefective fabrics. Some defects in the dark blue and black fabrics were not identified, perhaps because of similarities between the colors of the fabrics and the defects. Therefore, defects can be easily identified if their colors contrast with those of the fabrics.

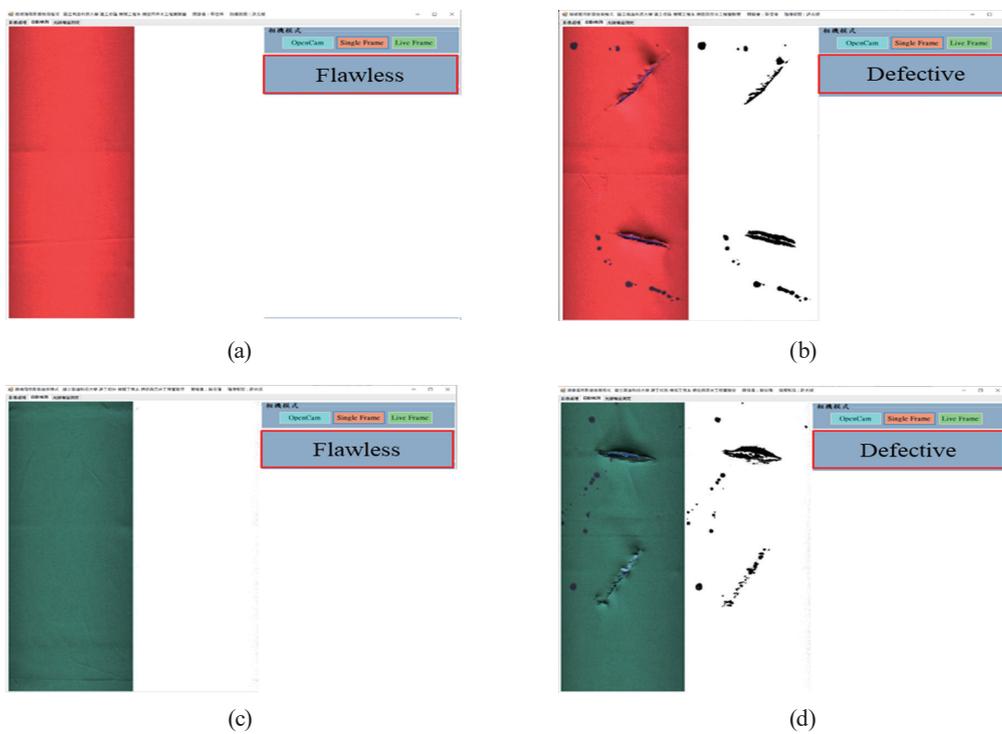
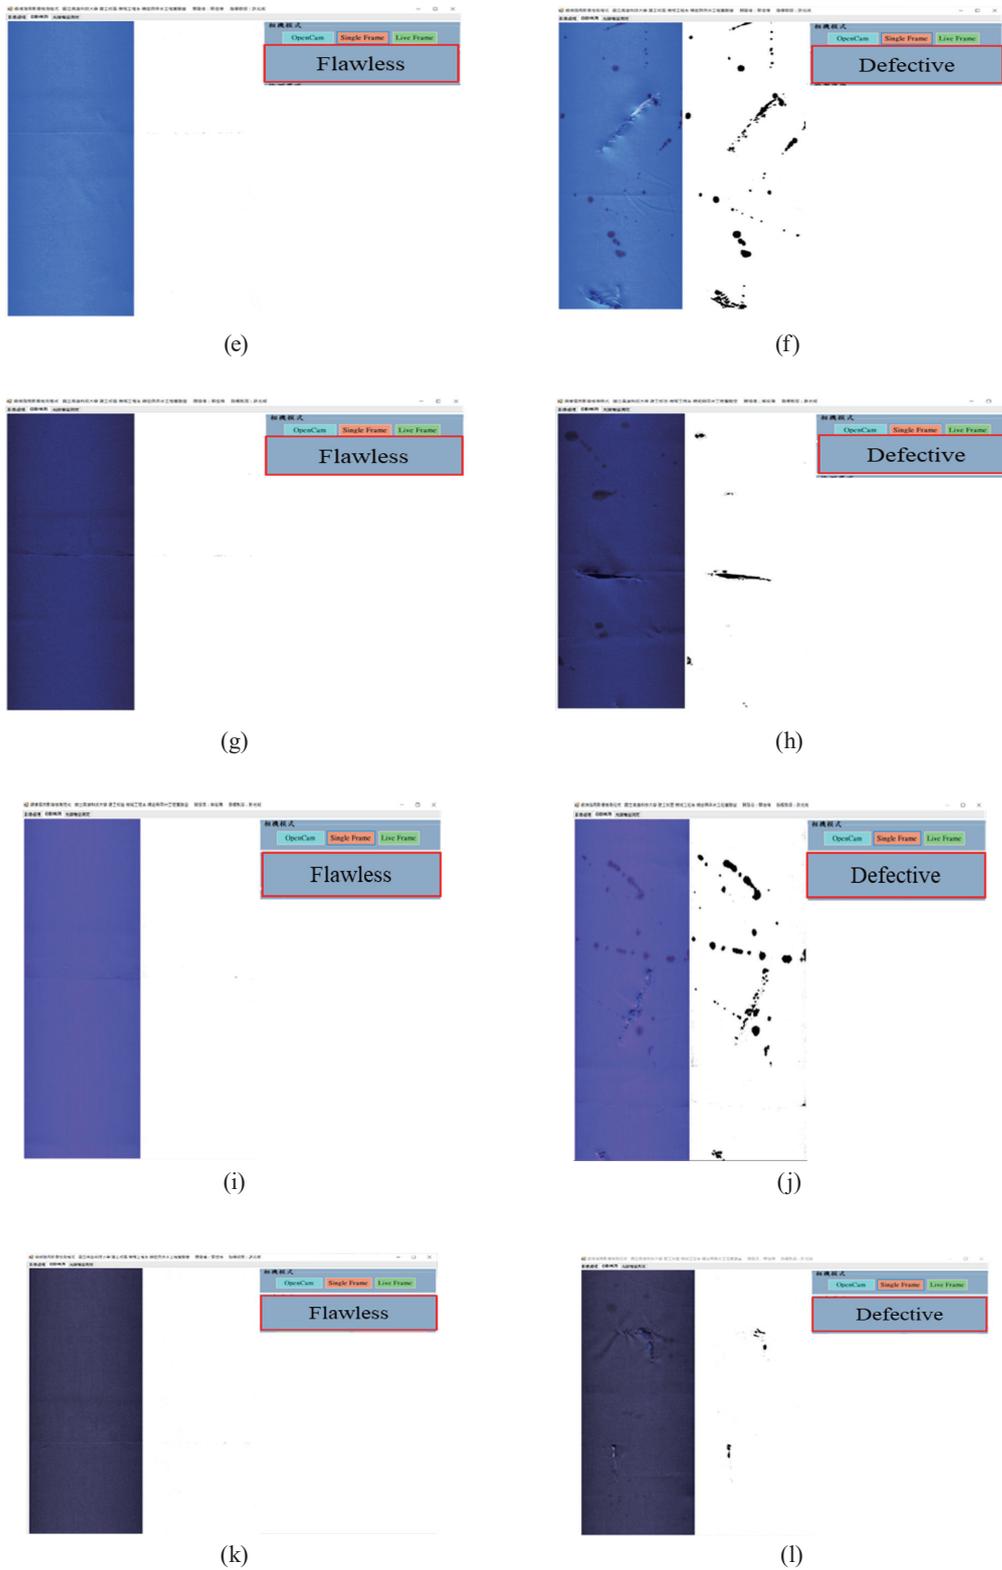
Fig. 16. (Color online) Results from the fully automated image inspection. (a) Flawless red fabric, (b) defective red fabric, (c) flawless green fabric, and (d) defective green fabric.

Fig. 16. (Color online) (continued) Results from the fully automated image inspection. (e) Flawless light blue fabric, (f) defective light blue fabric, (g) flawless dark blue fabric, (h) defective dark blue fabric, (i) flawless light purple fabric, (j) defective light purple fabric, (k) flawless black fabric, and (l) defective black fabric.

The posterization parameters and the contour detection area were used for the determination of upper and lower limits. The mismatch between the roller and the image capture caused the same defect to appear at a different position every time an image was taken. Under continuous rotation of the roller, multiple inspections were performed using the AOI system. As shown in Fig. 16, the system correctly identified the presence or absence of defects in all the fabrics.
